**MAGNETI  
MARELLI**

PARTS & SERVICES

# TIMING CHAIN KIT

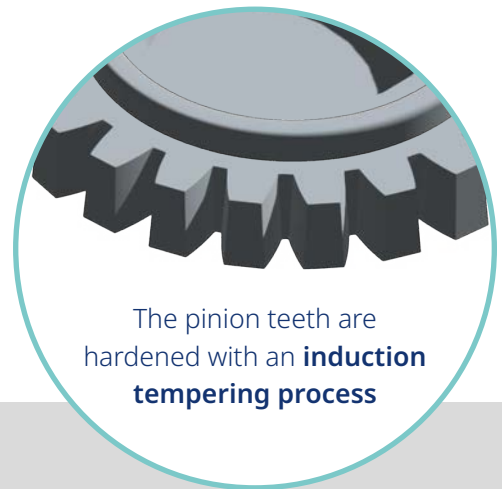
The pinion teeth are hardened with an **induction tempering process**

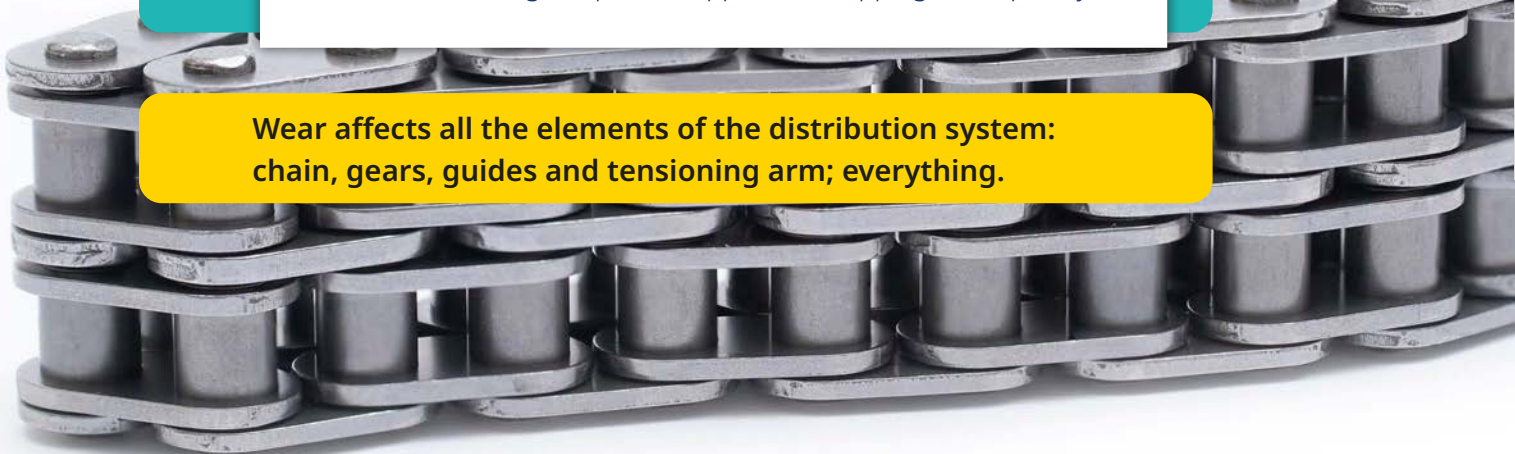
**Wear affects all the elements of the distribution system: chain, gears, guides and tensioning arm; everything.**

Some noise can be caused by an excessive lengthening of the timing chain. **Pay attention to these signs** during the different stages of engine function:
